# Identifying Acoustic Leaks

**John Campbell, Campbell Associates Ltd**

**Richard Divey & Lesley Oldfield, Norwich City Council**

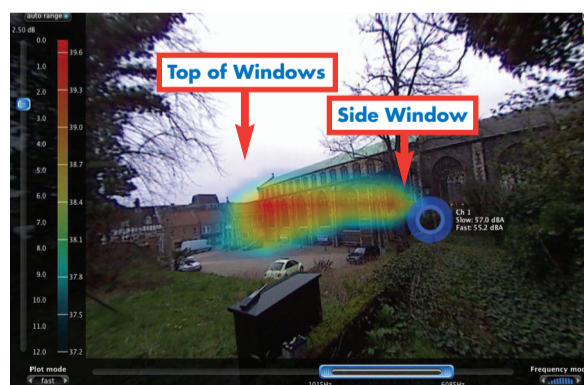
Figure 2: Acoustic camera image from distance

Two main areas could be seen where sound was leaking from the hall. The first was a side window closest to the camera in figure 2. The second was from the top of the windows on the main façade. In order to identify this the acoustic camera was moved closer to the hall.

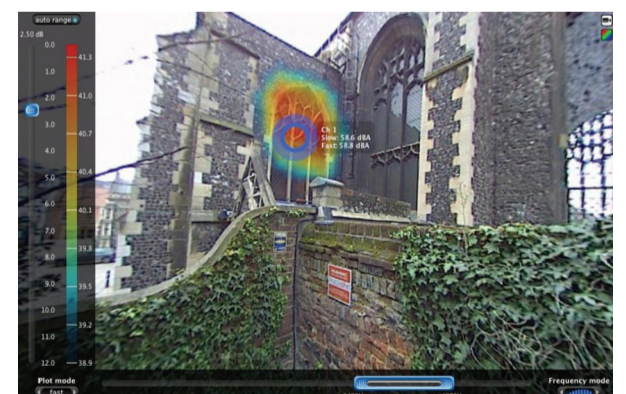
Figure 3: Acoustic camera image of side window

The camera was placed approximately 5m from the side window. This window shows an obvious acoustic leak as can

be seen in figure 3. This window has not received secondary glazing and from the acoustic camera it can be seen it has a significant contribution to the sound level at the nearest

residential receptors. An improvement would be seen if this window was secondary glazed.

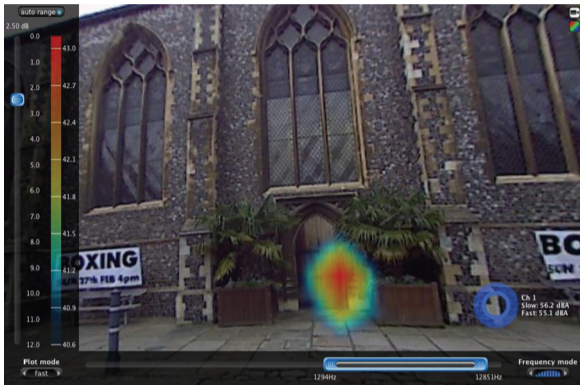
Figure 4

The inner acoustic door was closed and the external door closed fully. From 1 kHz onwards a leak could be seen in figure 4 where the seal was missing on the external door (figure 5). On the internal acoustic door it was discovered that there was a seal missing as can be seen in figure 6.

Fixing these seals would improve the sound insulation with minimal cost.

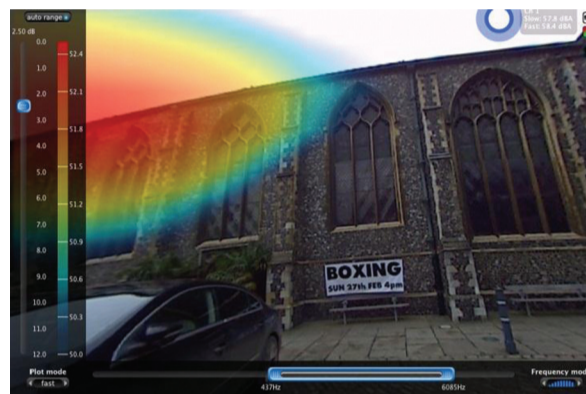
Figure 7: Measurement at main façade

Placing the acoustic camera close to the main façade it could be seen that the sound was leaking from the far end of the building. This can be seen in figure 7.

By using the virtual microphone with the camera (the blue circle seen on the screen) it can be placed on any part of the screen to hear this area in isolation. A significant leak could be heard and seen to the far end of the building. Notice the bird on the video file?

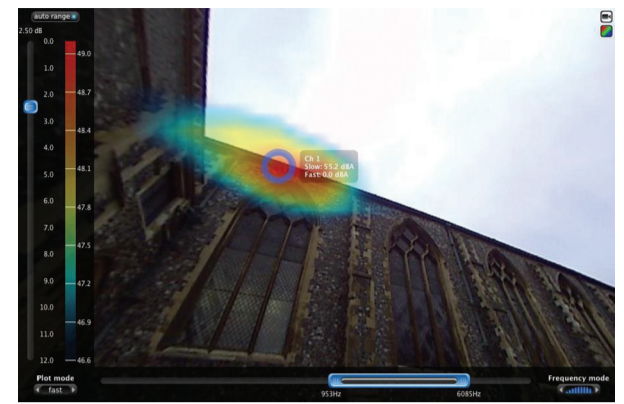
Figure 8: Acoustic leak pinpointed

The acoustic camera was placed close to the façade at the far end of the building and significant acoustic leak was identified above the window on the far end of the building.

The construction of the building is masonry with large wooden beams laid across the top of the walls to support the roof. The leak could be pinpointed to a major beam located above the window in figure 8 above. Of the leaks detected this is the most significant acoustic leak at the hall and the

main contributor to higher levels than expected at the receivers. To a lesser extent a leak was detected on the second window from the left in figure 8.

The main leak above in figure 8 needs further investigation. A cherry picker/ working platform is required to access the pin pointed areas. It is likely that repairing the masonry will improve the sound insulation significantly.
