# Nordic District Heating Networks Monitored from the Sky with Thermal Imaging

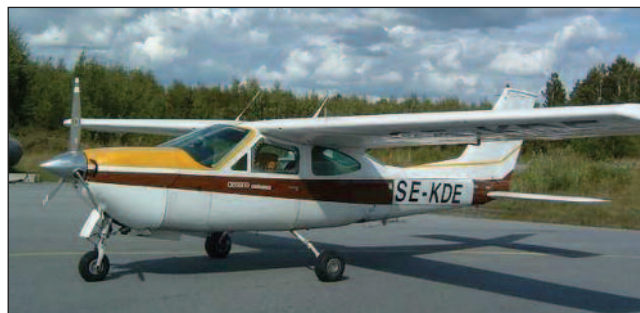
The FLIR SC7600 thermal imaging camera is mounted in a plane, looking straight down through an opening in the plane's hull.

For the district heating inspections the thermography experts at Termisk Systemteknik have mounted a FLIR SC7600 on the bottom of a small plane. By flying over the city and recording the thermal images, a thermal map is produced of the entire city on which district heating leaks can be detected and localised. An automatic detection system is unleashed on the thermal data to automatically point out leaks and other issues to the district heat maintenance teams. “To be able to arrive at this result we needed to perform a lot of research ourselves,” explains Stefan Sjökvist, director of Termisk Systemteknik. “To my knowledge no such system existed before we designed it.”

The FLIR SC7600 thermal imaging camera that was used for the district heating monitoring system contains a cooled Indium Antimonide (InSb) infrared detector that produces thermal images with a resolution of 640 x 512 pixels at a thermal sensitivity of 20mK (0.02 °C). “It is especially useful for this application because of its high frame rate and short integration time. It can capture the full resolution at a frame rate of 100 Hz. Such high speed acquisition and short integration time is indispensable when you are flying over a city at moderate speed and want sharp and clear images.”

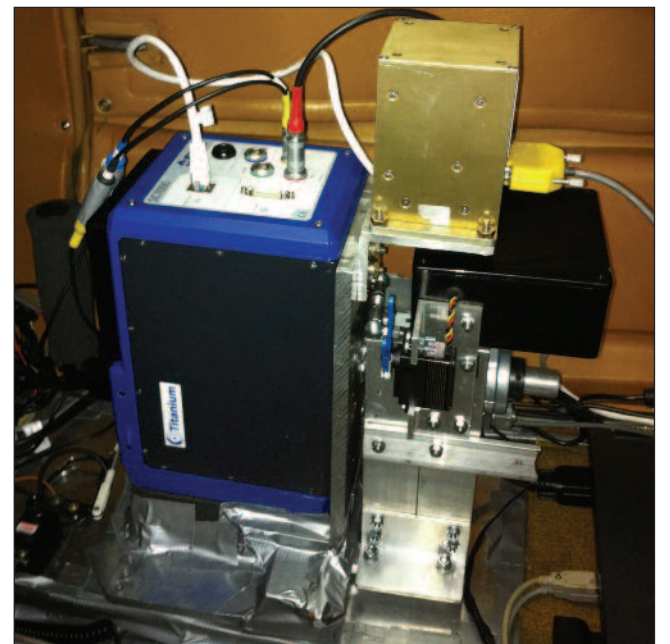
A gyro-stabilized platform compensates for the plane's movements, enabling the FLIR SC7600 thermal imaging camera to record steady thermal images.

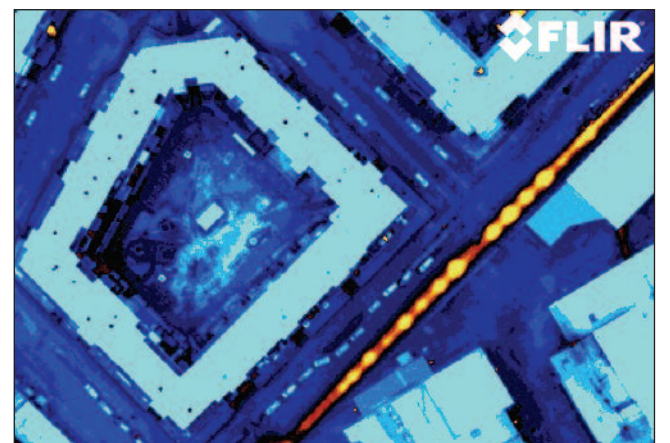
This un-analyzed thermal image already clearly shows leaks in a district heating pipe.

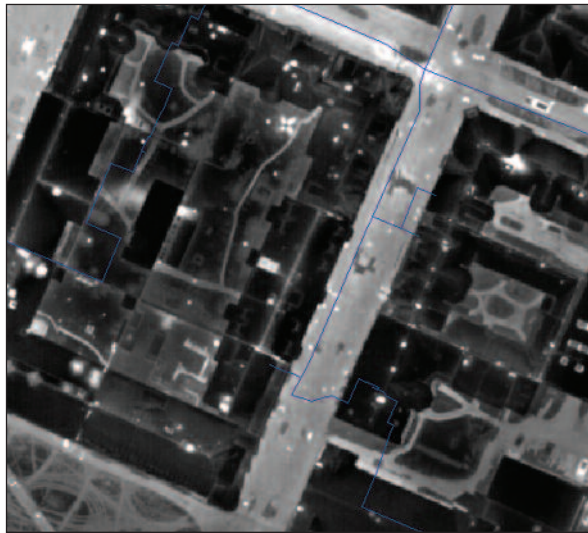
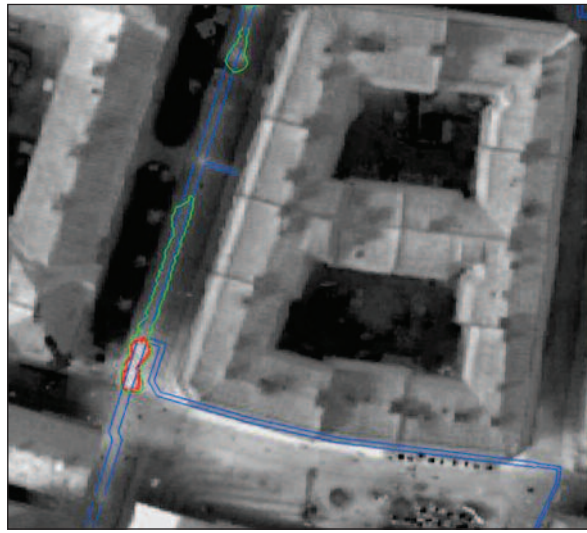
The thermal images are analyzed and an extra layer of information is added. District pipelines are marked with blue lines. Green outlines mark smaller leaks and red outlines mark serious leaks that require immediate attention.

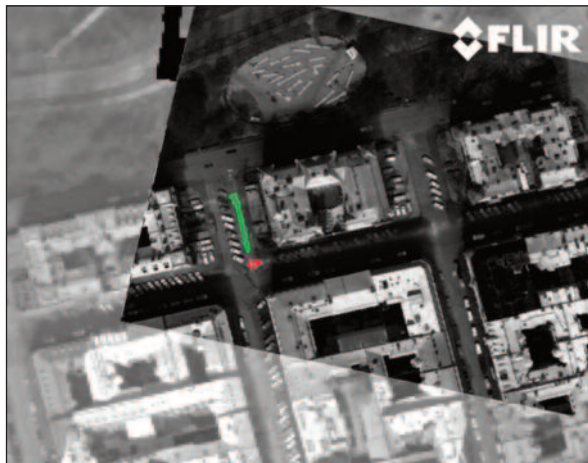
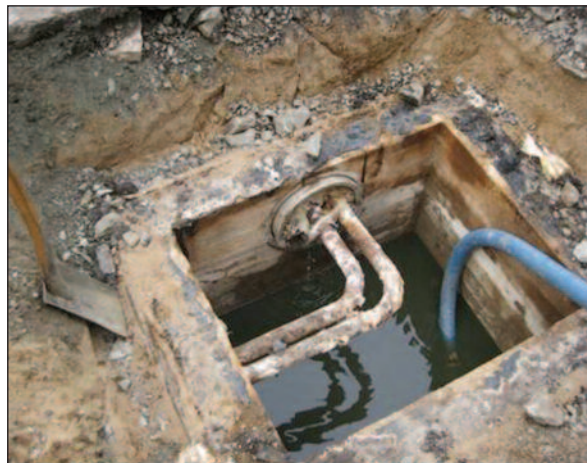
After seeing this leak in the report, the district heating company went there to investigate. It turned out to be a very large leak. Needless to say the company was very glad that this major leak was detected.
