Renowned Russian Research Institute Uses Thermal Imaging to Monitor Temperatures in Siberian Permafrost

Kristof Maddelein, FLIR Systems, kristof.maddelein@flir.com

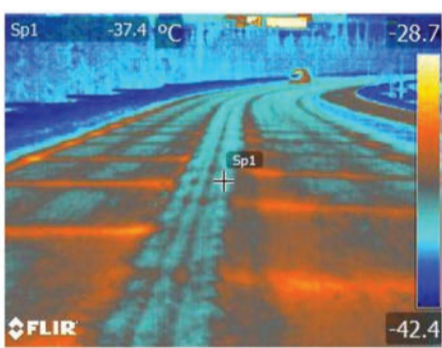
Thermal imaging can be used to see whether cooling devices of road infrastructures are working effectively.

"Thermal imaging can be used to see whether these cooling devices are working effectively," says Julia Stanilovskaya. "These cameras can also be mounted on drones to perform aerial thermography on pipelines, railways or road infrastructure."

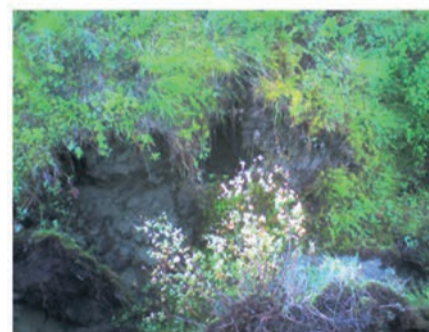
Natural thaw subsidence along ice wedges on the terraces of Chara river (August 2013)

The possibilities of thermal imaging cameras for permafrost research are numerous and the types of phenomena that can be detected quite varied. Even very cold objects, such as ground ice, emit thermal radiation. That's why thermal imaging cameras can reliably detect ice wedges at the distance of 400 to 500m and measure the temperature of ground ice in local areas. The study of ground ice and icy sediments aims at identifying problem areas and possible solutions for infrastructure works in permafrost areas. Thaw subsidence may occur both on man-made objects and in natural conditions.

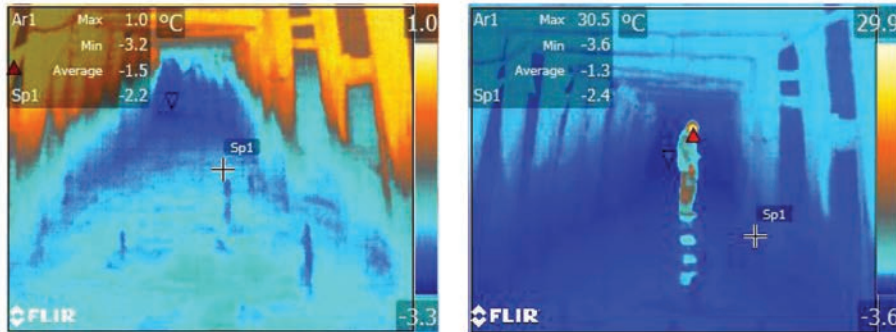
Thermal imaging can also be used in support of mining and tunnel construction works in permafrost areas. (Udokan Ridge tunnel works, similar to the Kodar tunnel works)

Thermal imaging can also be used in support of mining and tunnel construction works in permafrost areas. In the year 1984, a rockfall occurred during railway tunnelling works in the Kodar mountain ridge in Siberia. This accident could probably have been avoided with regular thermal measurement of the rock temperature around the perimeter of the tunnel. Using thermograms on time could have helped to avoid the rock collapse and to take the necessary measures to maintain the temperature and mounting arch.
