# Identifying Acoustic Leaks

**John Campbell, Campbell Associates Ltd**

**Richard Divey & Lesley Oldfield, Norwich City Council**

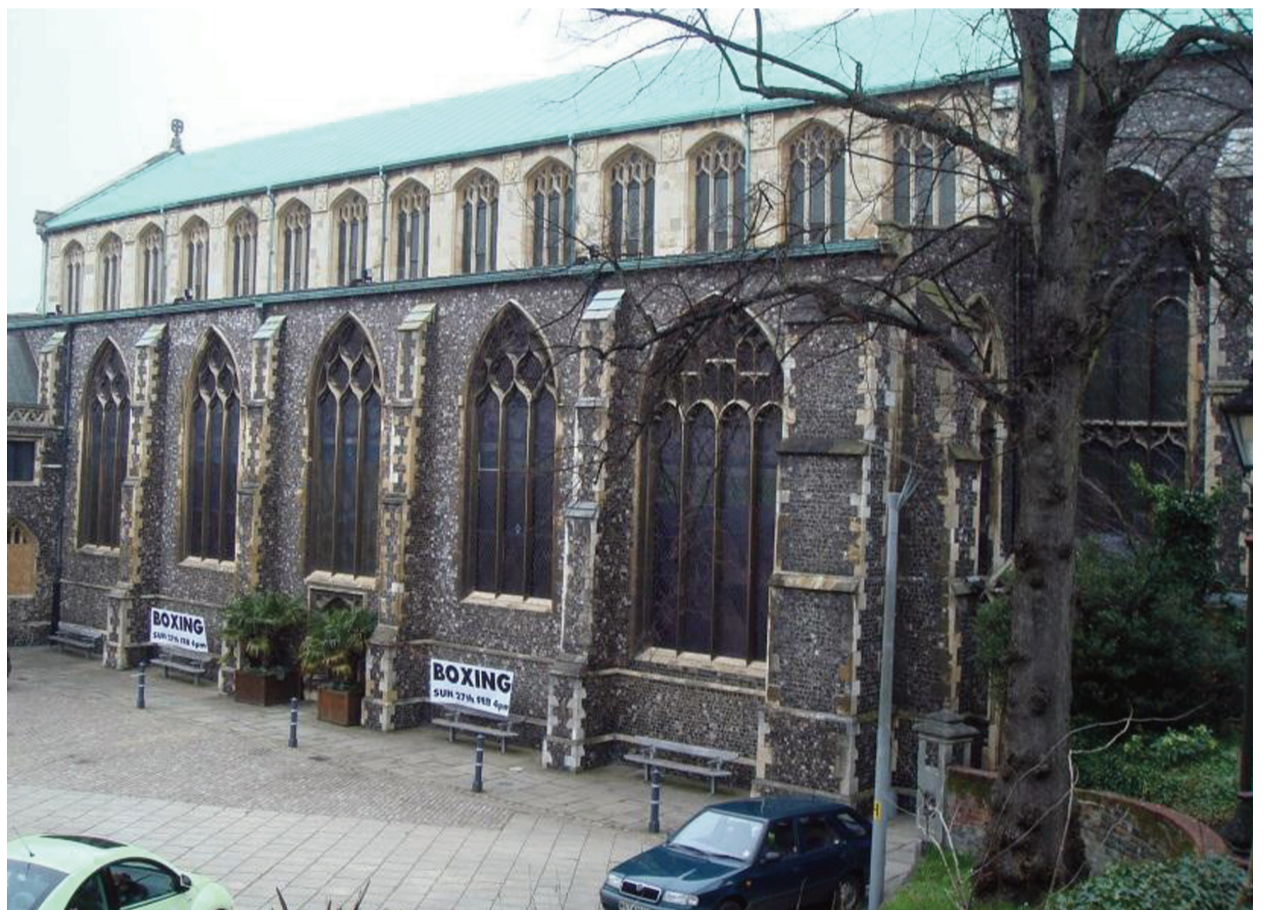
Figure 1: St Andrews Hall

In order to reduce break out noise secondary glazing has been installed on the first and second floor of the hall opposite the flats. These windows can be seen in figure one below.

In order to identify acoustic leaks on the main façade as shown in figure 1 additional loudspeakers were placed in the hall playing pink noise to give an internal reverberant sound pressure level of 105dB(A). The acoustic camera was then pointed towards the façade to see if leaks could be detected.
